Memorandum

Date: *August 15, 2014*

Subject: *Oversight Summary Report
CPG Oversight of RM 10.9 Removal Action
Lower Passaic River Restoration Project*

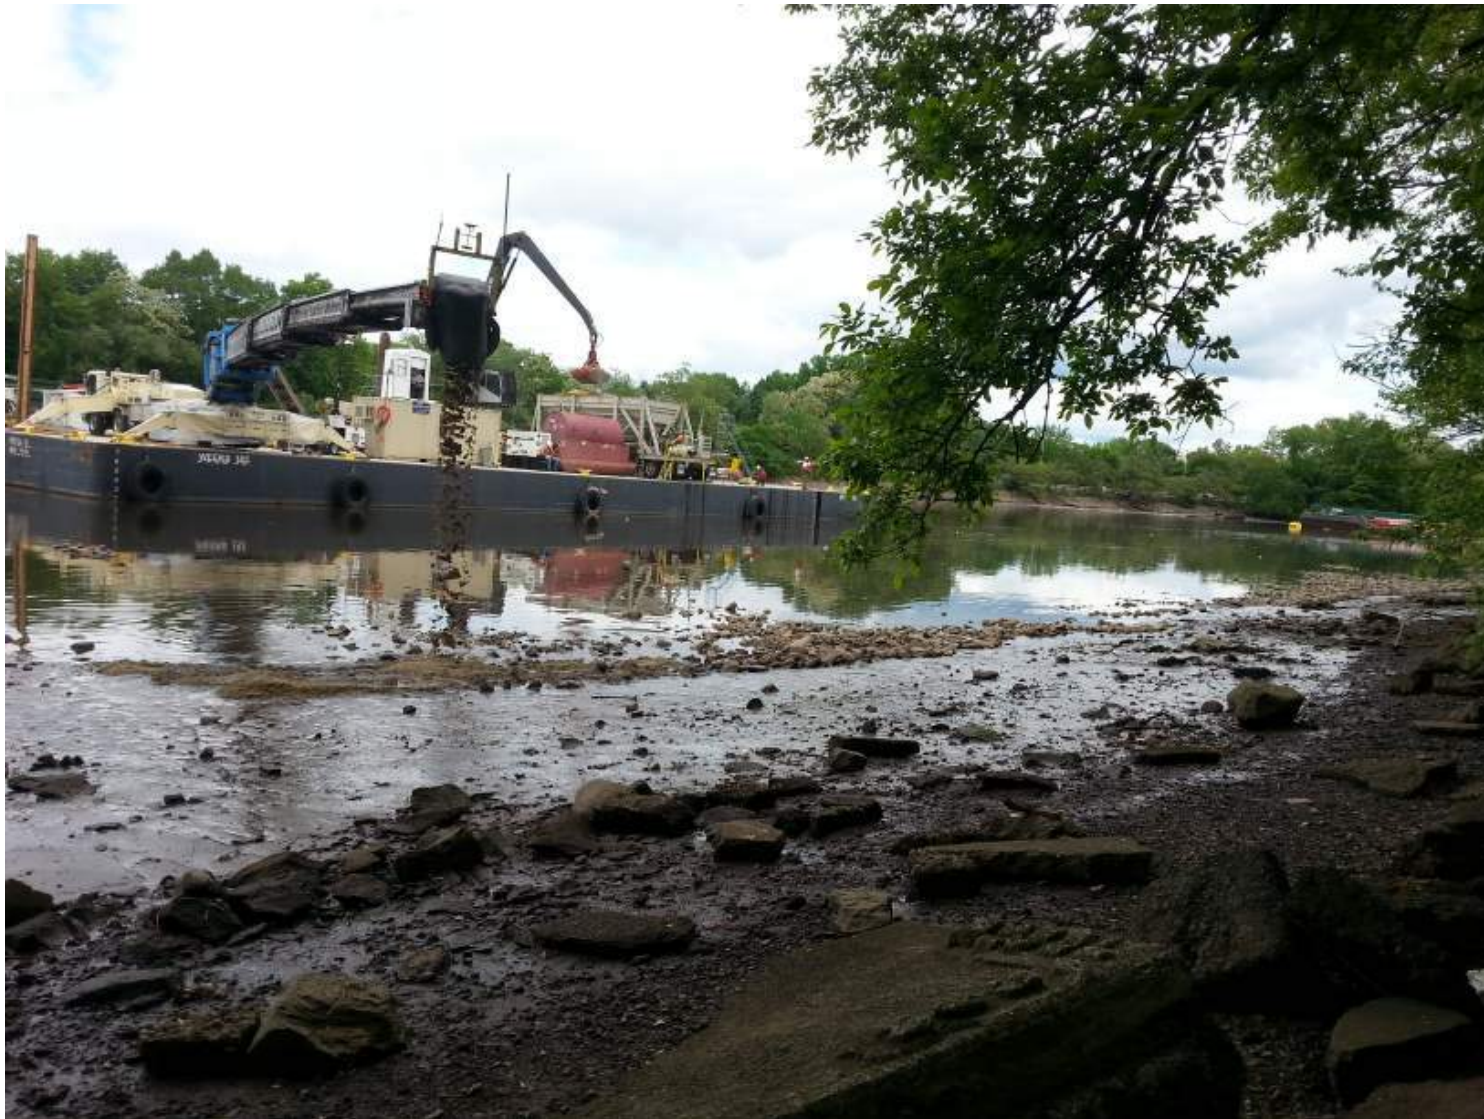
May 24, 2014 1407: GLDD placing habitat layer placed during low tide, immediately north of the No Dredge Zone.

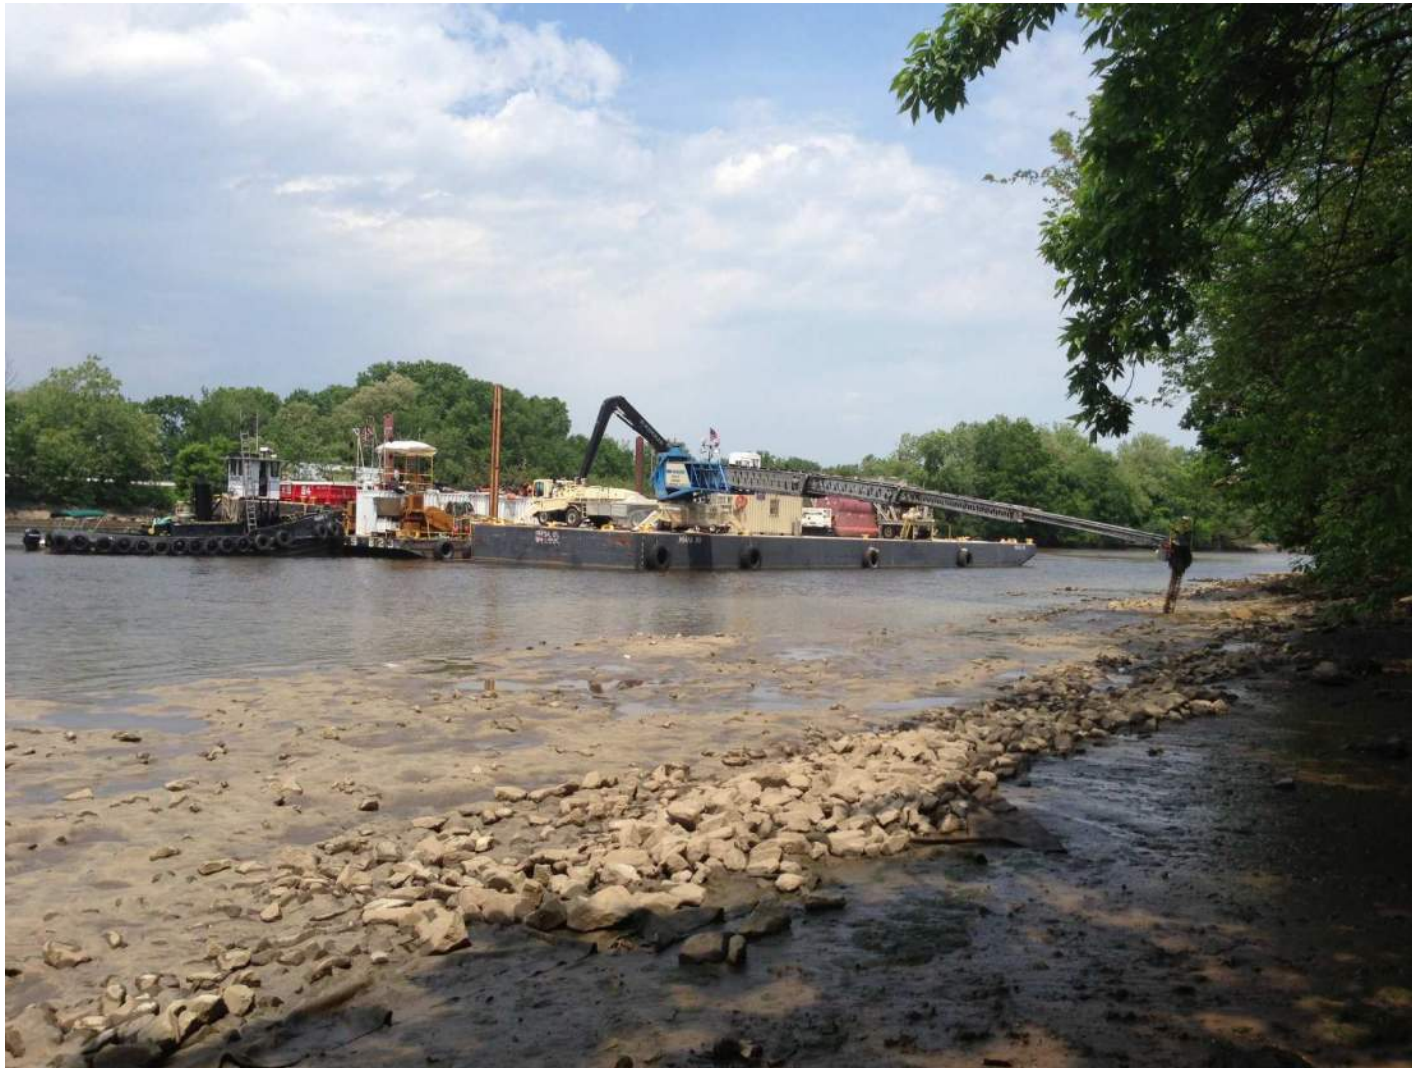
Habitat Layer Placement and Previously-Covered Area

In the background of the above photograph, the telebelt is applying the first lift of sand to an area just south of the Fire Department boat launch. The foreground shows an area that was covered last week, including a strip of exposed armor stone outside the “dredge line”. Per John Rolfe, GLDD currently do not plan to cover these areas with sand.

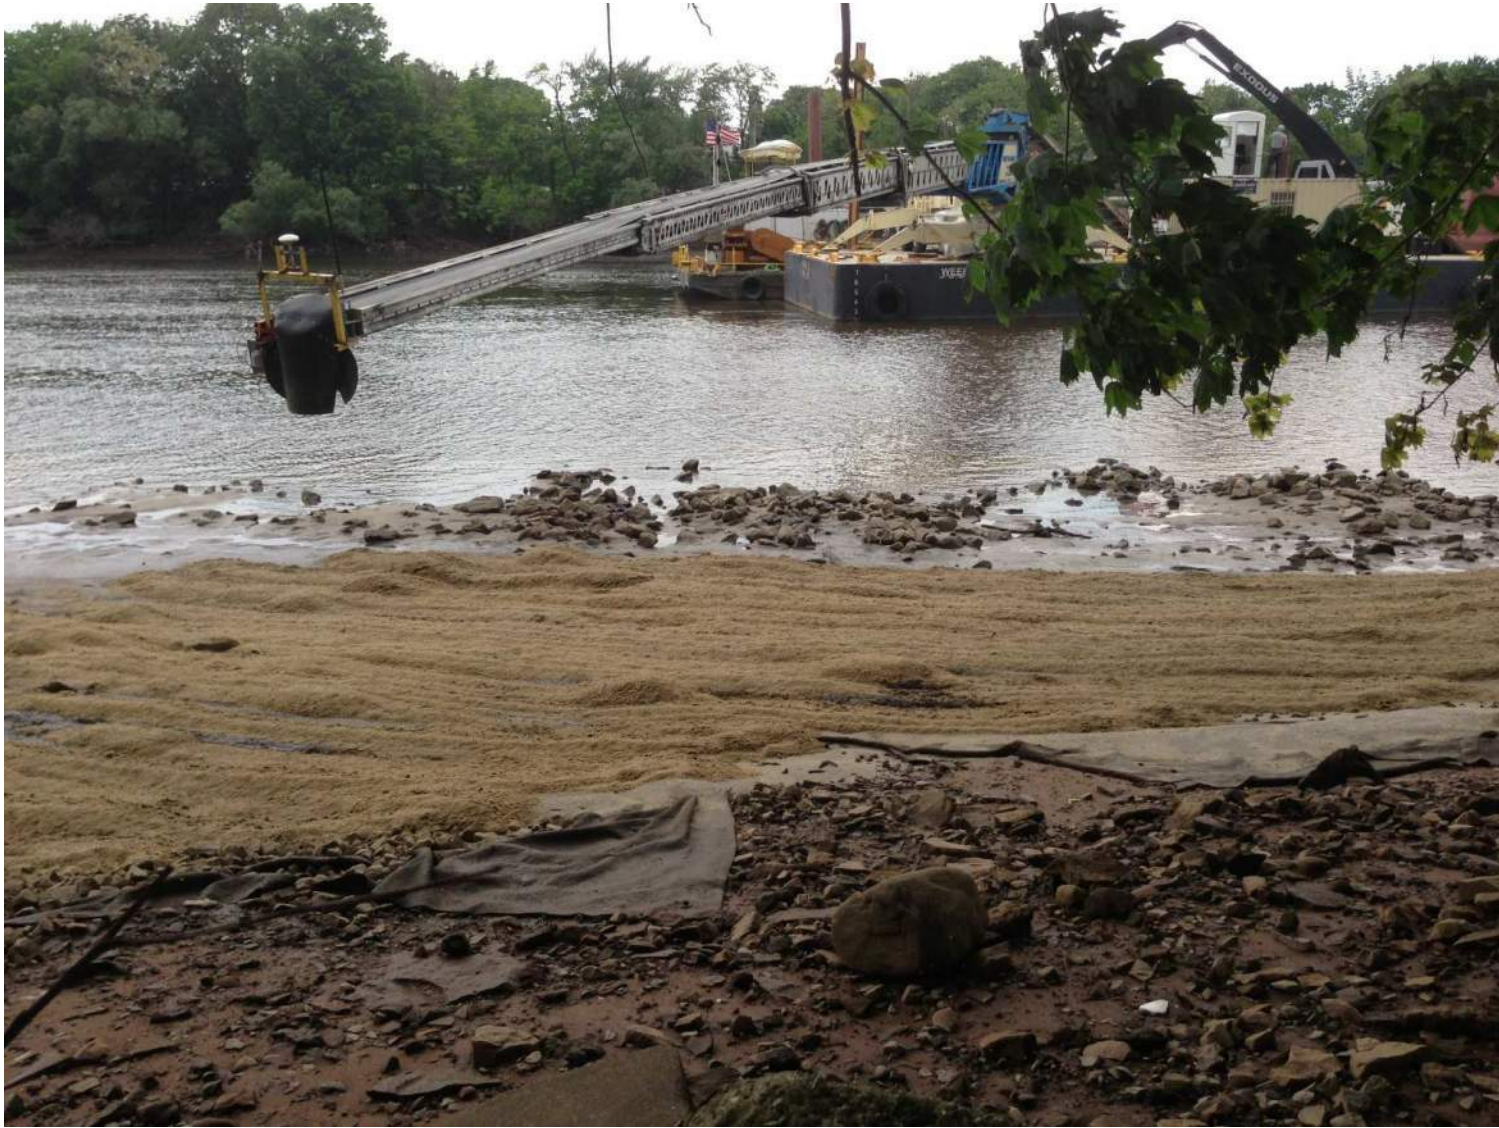
Habitat Layer Placement – Second Lift

The telebelt is shown placing the second lift of sand over an area. The background, beyond the fresh sand, shows an area between first and second lifts.

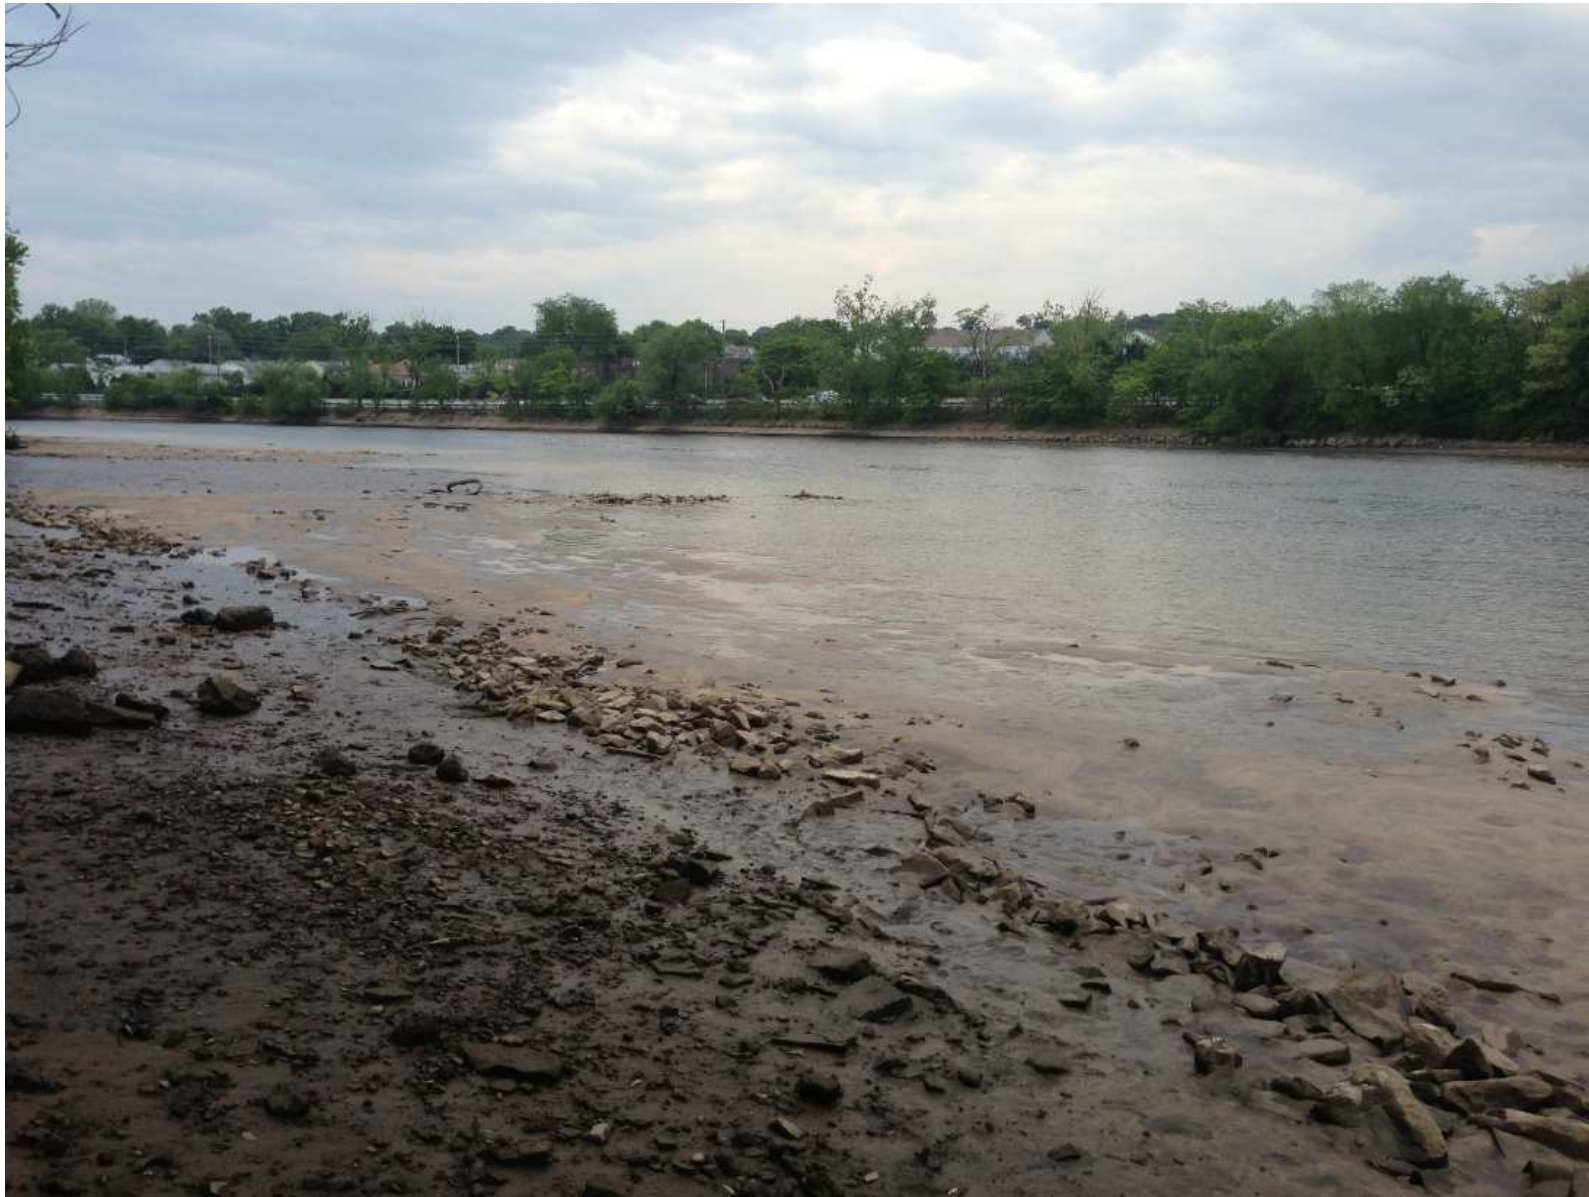
North of No Dredge Zone, Facing South

Strip of armor stone (beyond the “dredge line”) at bottom-right of photograph and extending toward center of photograph.

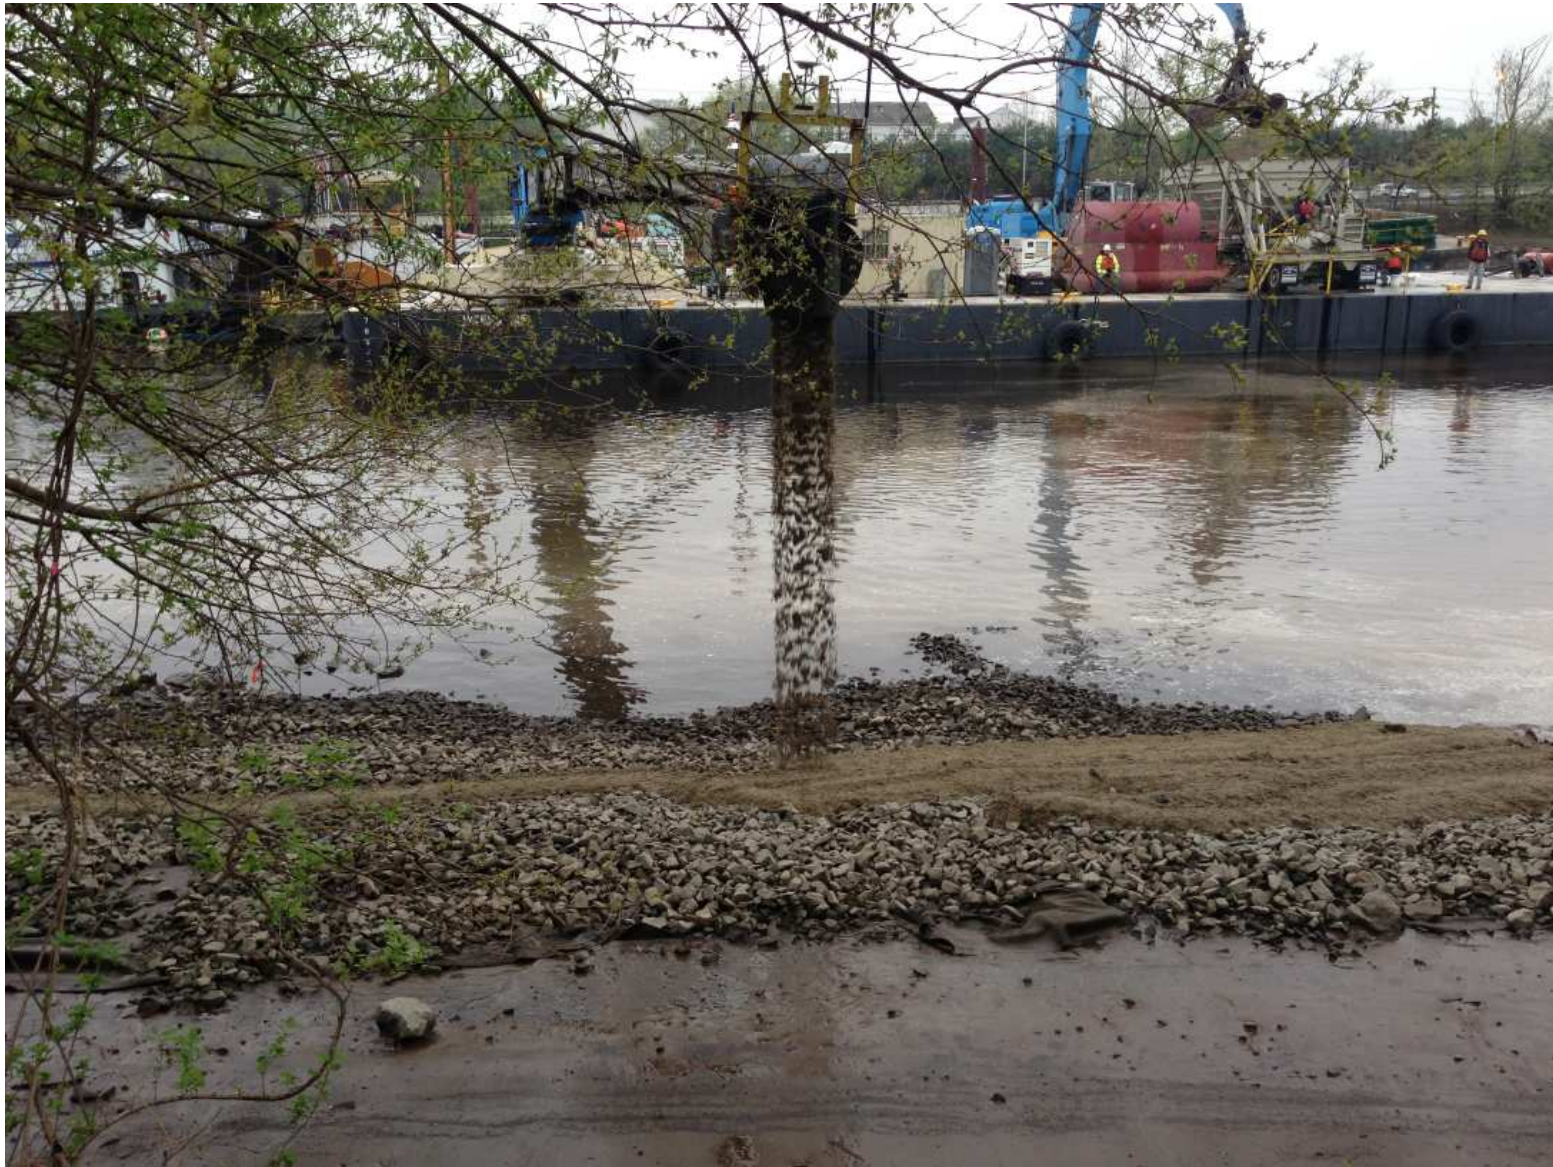
Initial Habitat Layer Placement – May 9th, 2014

The above photograph shows an area south of the No Dredge Zone during habitat layer placement earlier this month. See the following page for a photograph taken weeks later for comparison.

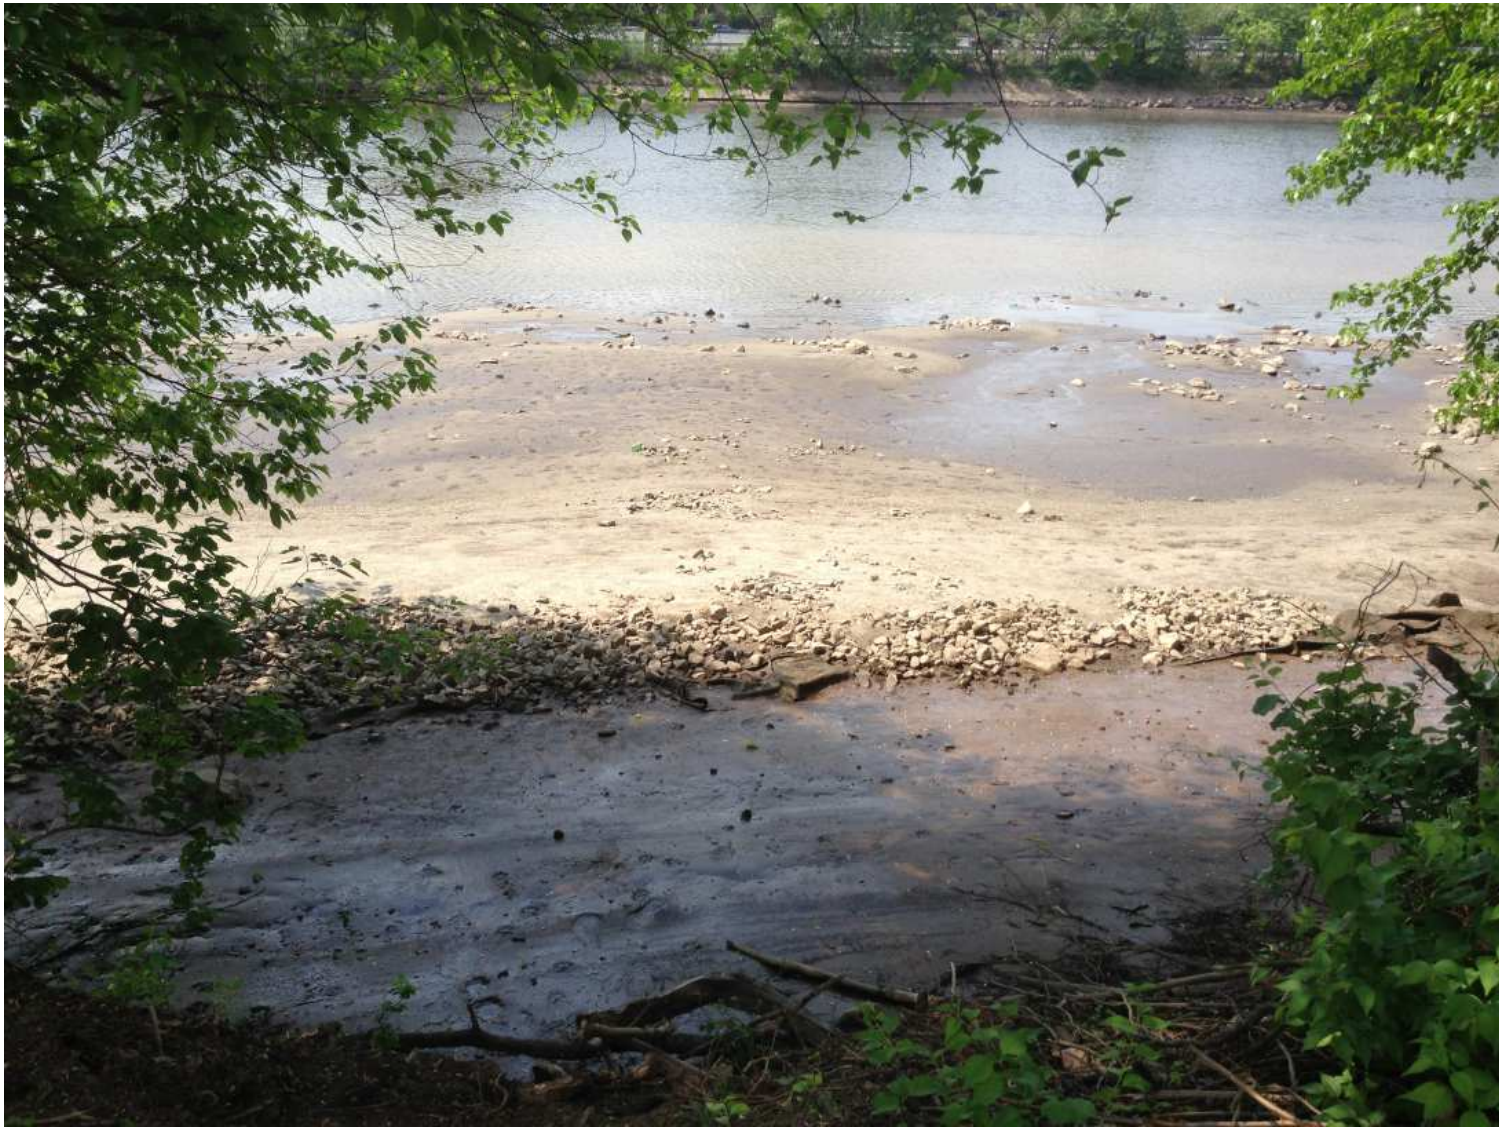
Habitat Layer – May 27th, 2014

This is the same location as on the previous page, after two lifts of sand were applied and over two weeks passed. The result is a generally uniform sand surface, with the exception of some residual armor stone outside the “dredge line”.

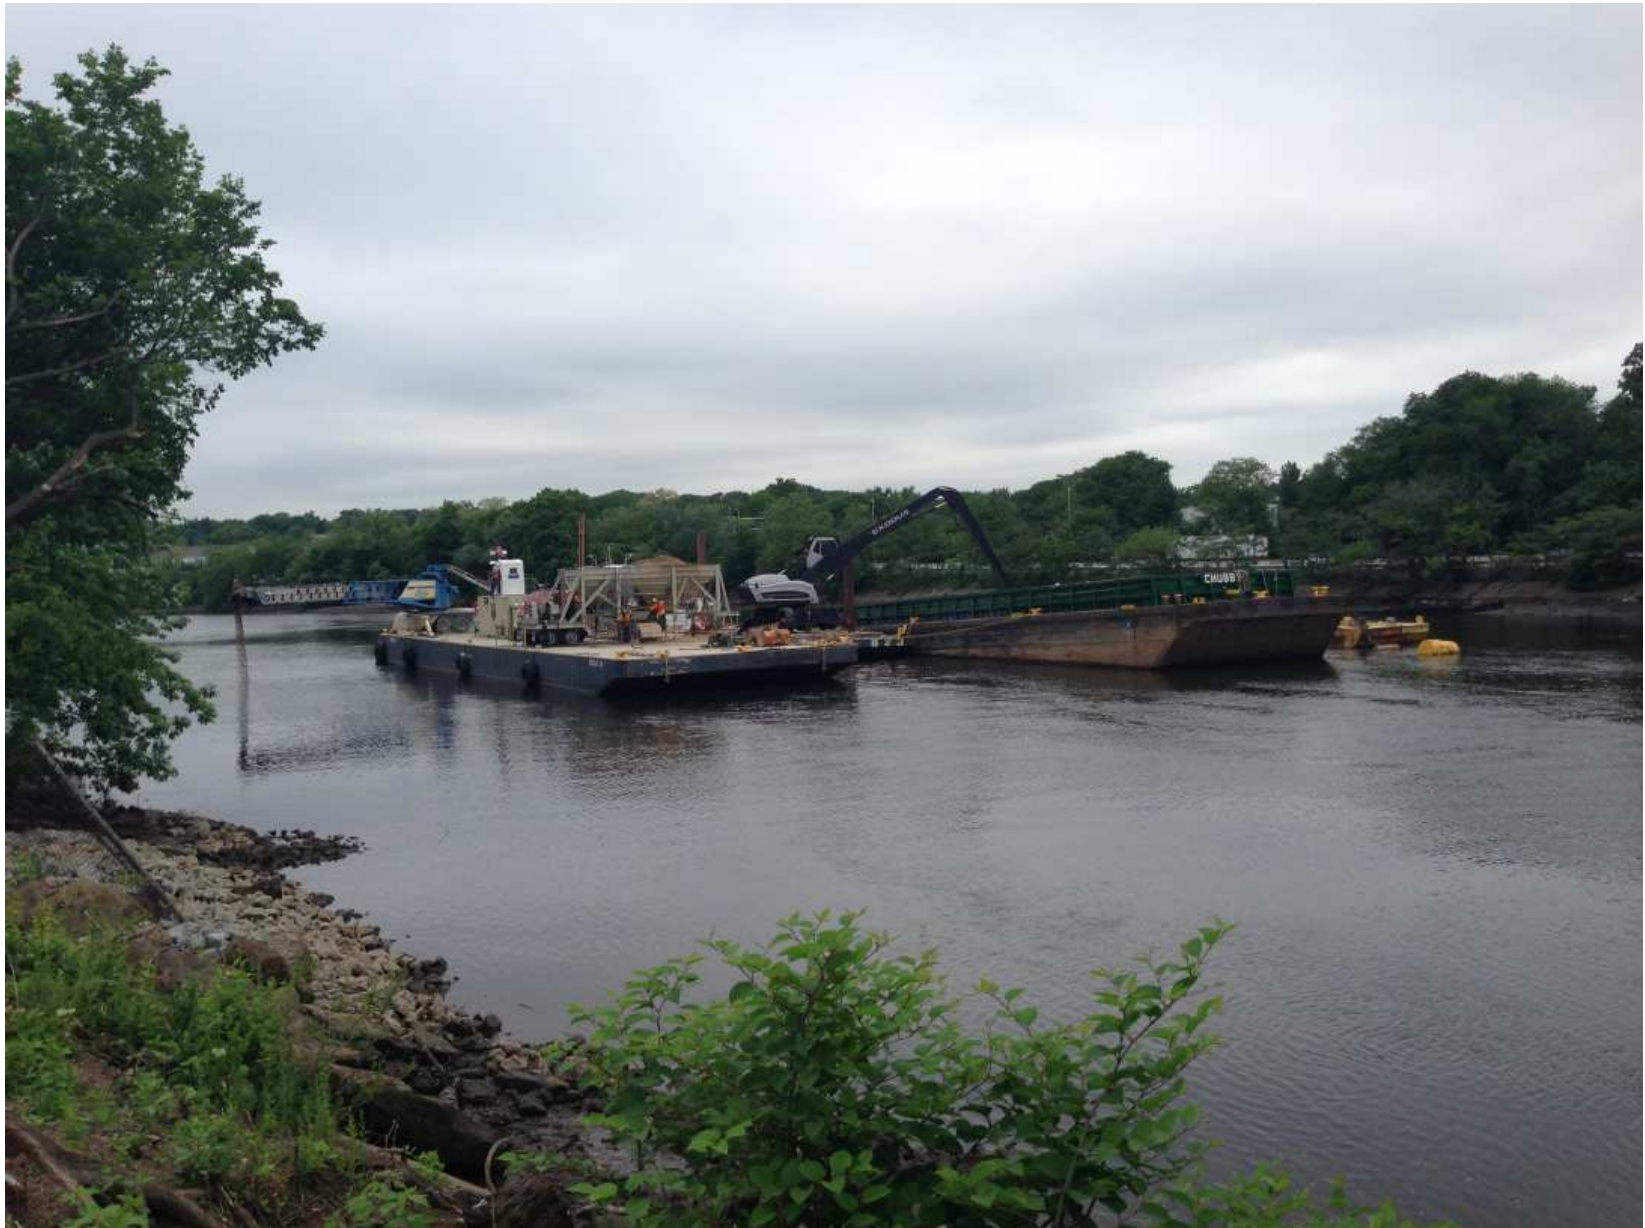
Habitat Layer Placement

GLDD placed sand north of the No Dredge Zone for approximately seven hours today.

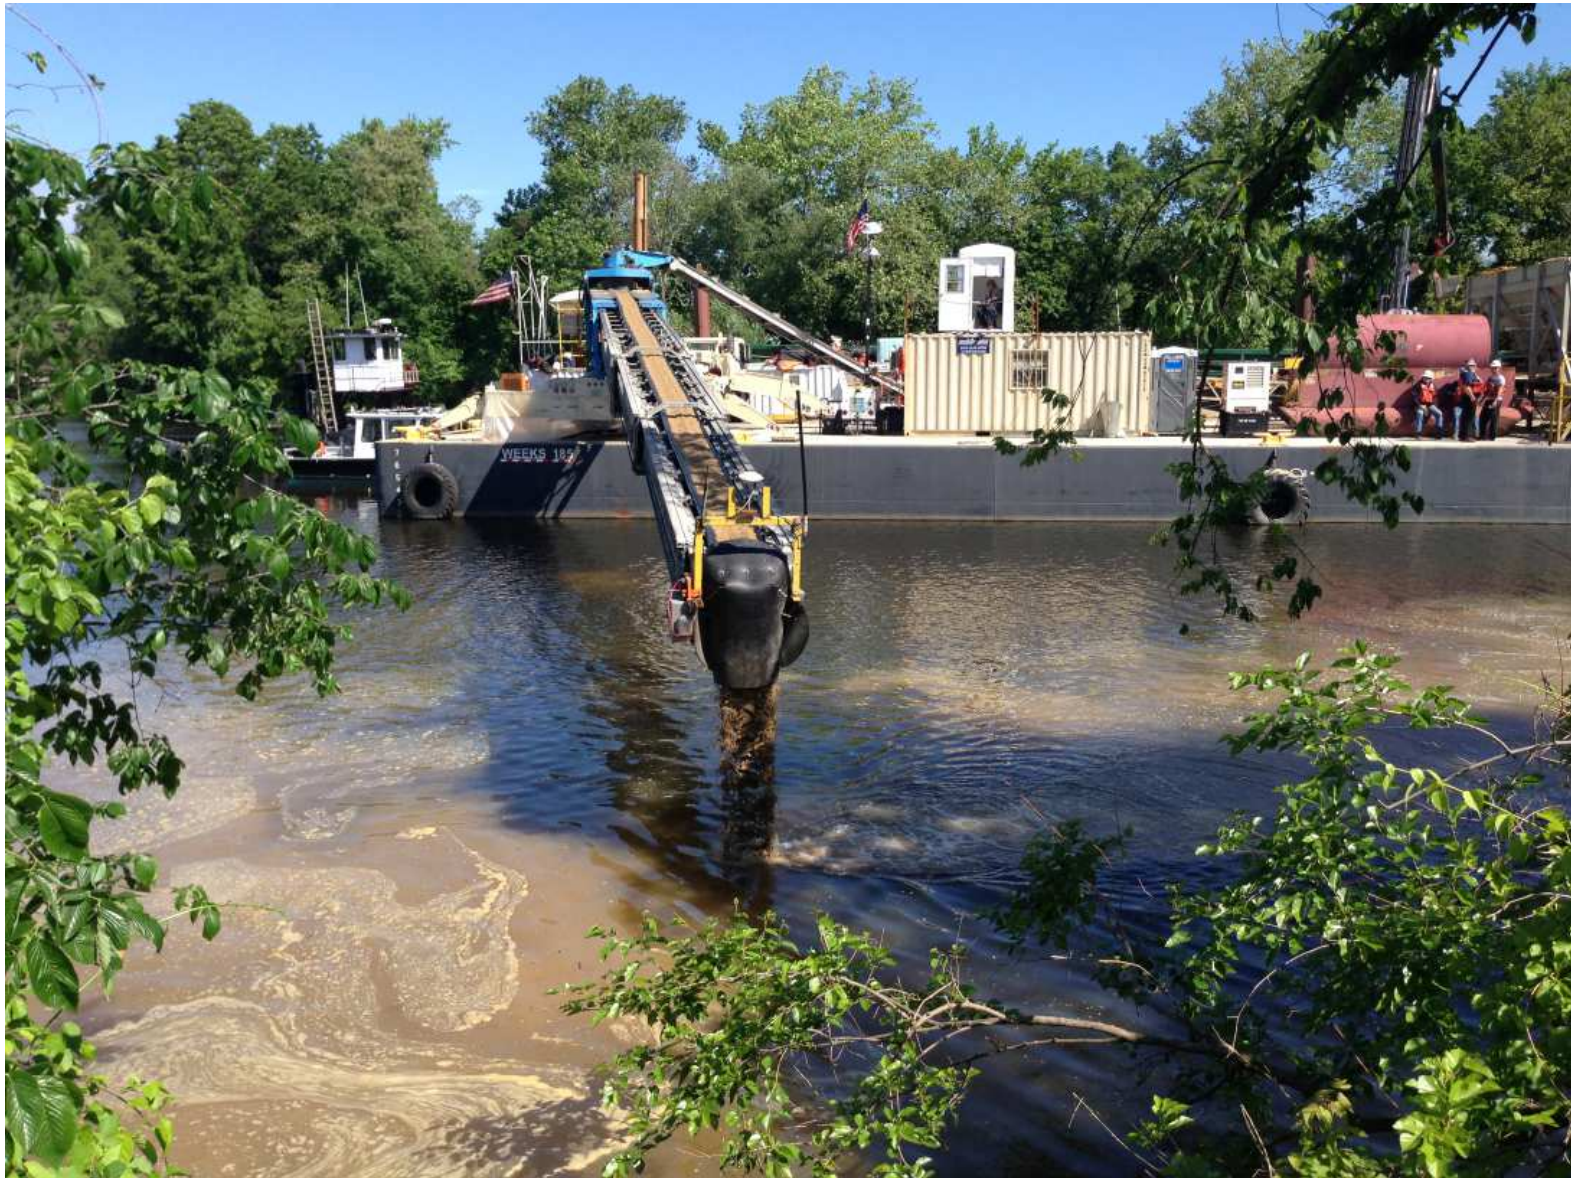
Habitat Layer Placement

GLDD completed placement of the habitat layer today, finishing at the northern edge of the capping area.

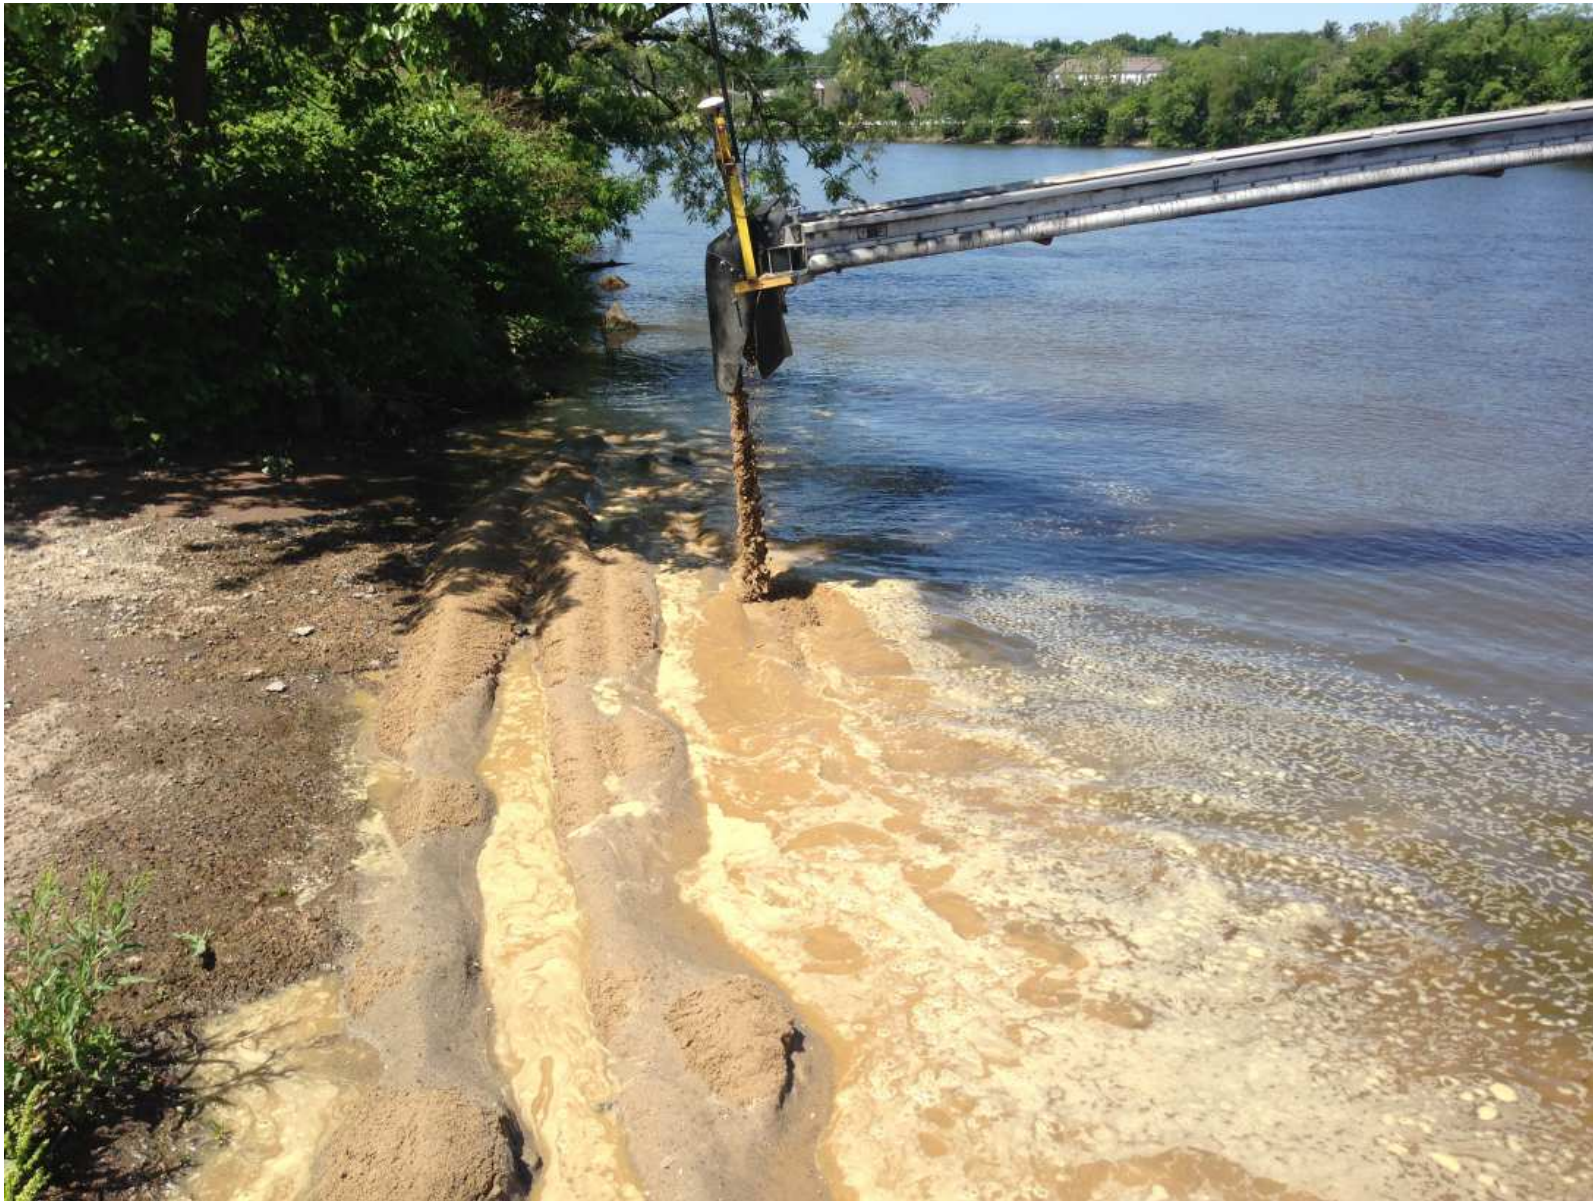
Extra Sand Placement

GLDD used the extra sand leftover in the Chubby scow at the Fire Department boat launch.

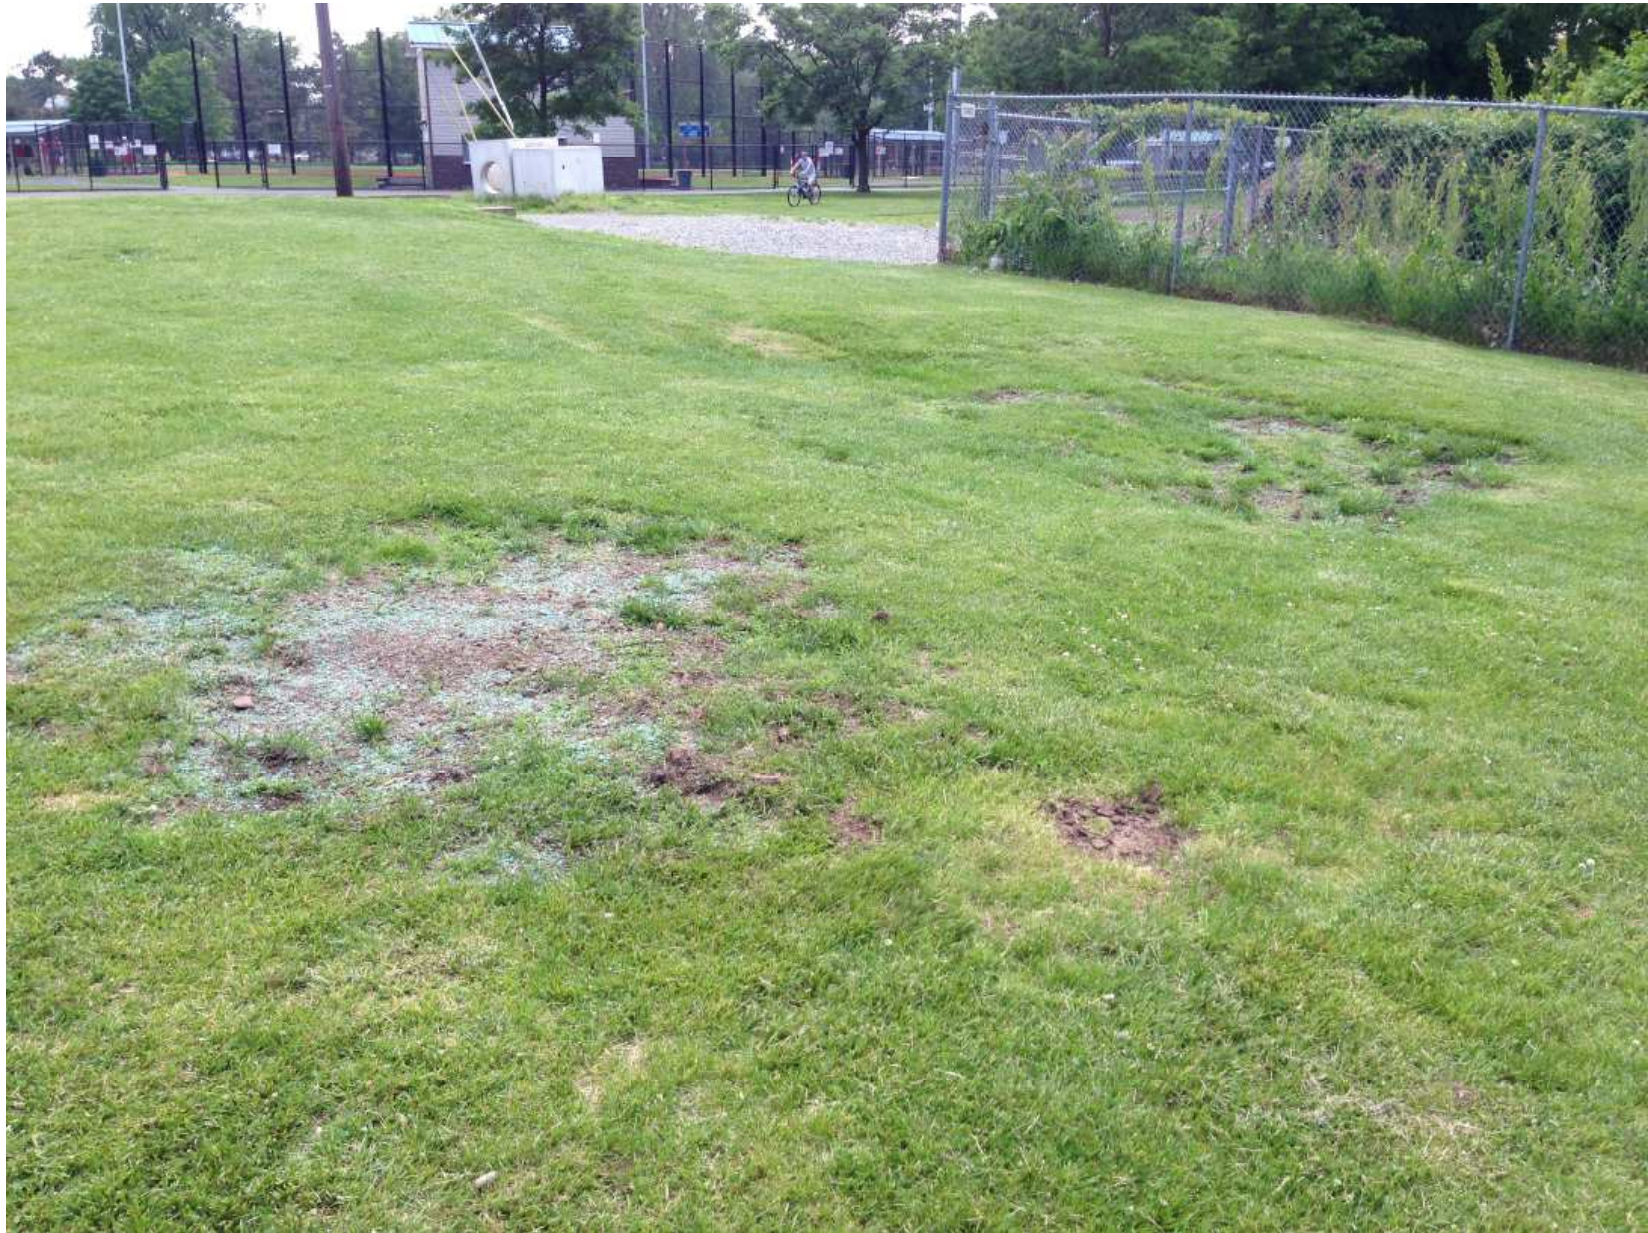
Grass Seed

GLDD raked and applied grass seed to park areas that were damaged during capping operations.
